On-Site Lake Evaluation Record

Lake Name: Cedar

Date: 5/23/13

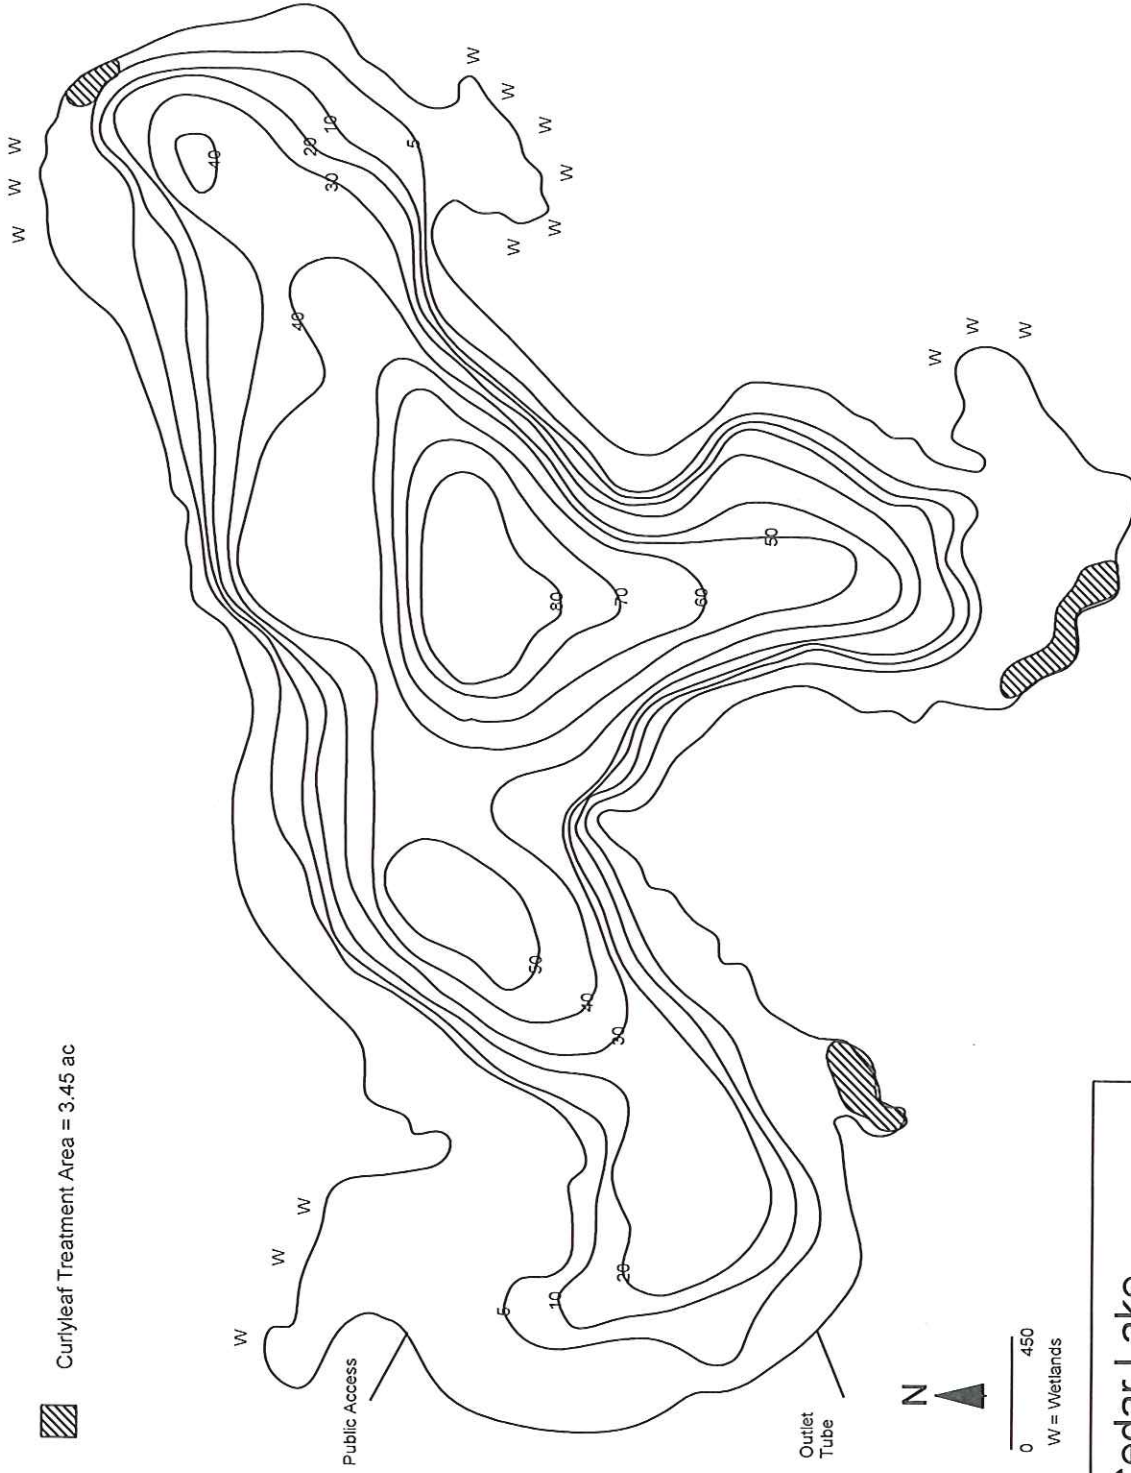
The overall condition of Cedar Lake is very good. No milfoil was observed at the time of survey and native plants were not causing problems. Three small areas of Curlyleaf pondweed (exotic species) were found and it is recommended that they be spot treated. While not as aggressive as milfoil, Curlyleaf can become a significant nuisance in the long term if not addressed prior to seed production. Please see attached map for recommended treatment areas.

Curlyleaf Treatment Area = 3.45 ac

- X Herbicide application (mark locations on map)
Need for herbicide treatments is: urgent, serious, moderate, x slight
